Manhole Inspection Summary

Manhole # S29YY_011MH

Location Address: **3236 KESWICK RD**

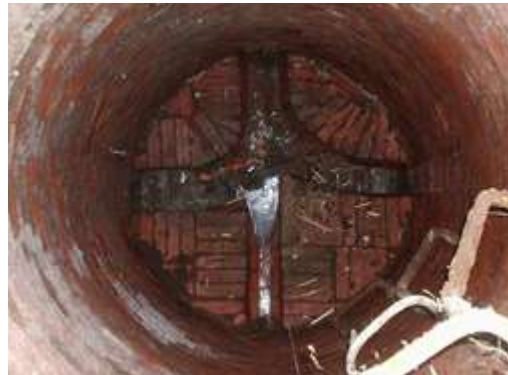
Top View

Corroded steps. Bench and Channel debris.

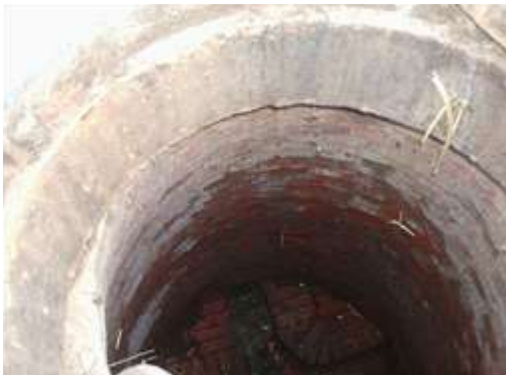
Defect

Frame leaks. Adjustment, Corbel and Barrel infiltration.

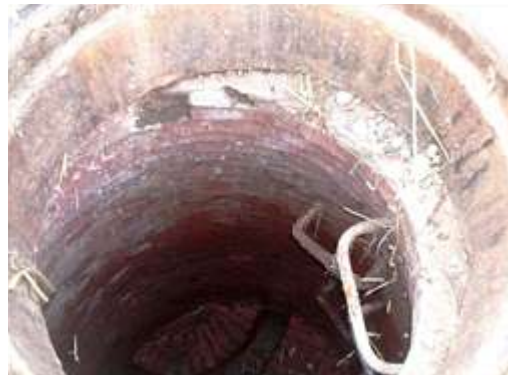
Defect

Frame leaks. Frame offset. Adjustment deterioration and infiltration.

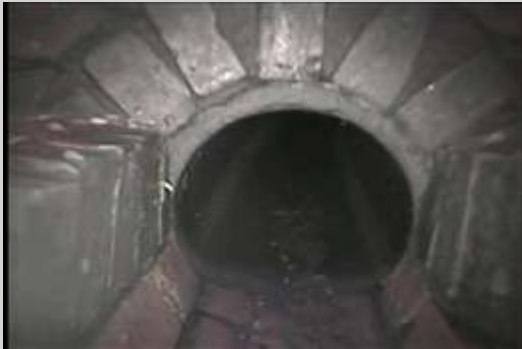
8 in. Circular Gravity Sewer Pipe Out @ 12 O'Clock

Deposits: ☐ None ☒ **Mud** ☐ Sludge ☒ **Debris** ☐ Grease

Silt Depth: **0** (in.) Deposits Extent: **Light**

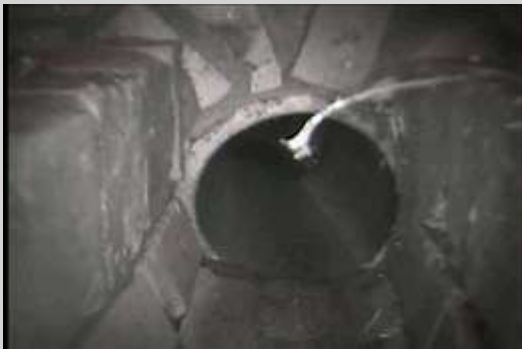
6 in. Circular Gravity Sewer Pipe In @ 3 O'Clock

Channel deterioration.

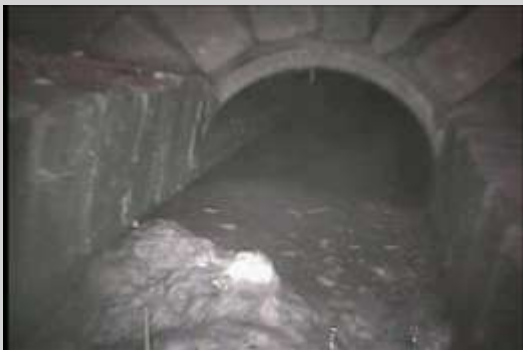
Pipe In @ 9 O'Clock

Deposits: ☐ None ☒ **Mud** ☐ Sludge ☒ **Debris** ☐ Grease

Silt Depth: **2** (in.) Deposits Extent: **Light**
